**SAS Superstructure**

Location: 04-SF-80-13.2 / 13.9

**Daily Diary Report by Bid Item**

Diary #: 075 Const Calendar Day: 884 Date: 09-Feb-2012 Thursday

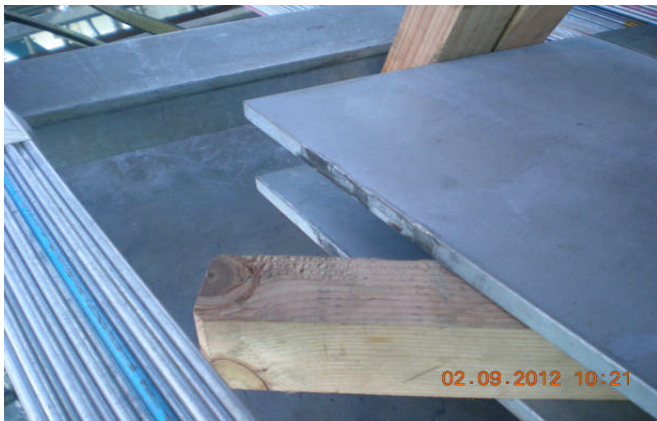
•About 10am, forming completed at NDS for strand # 31. Observed paint chipping off the divider plate halves and the steel is exposing bare metal along the edges of the same divider plate. Informed ABF engineer and it was agreed that this area where the steel was exposed can be painted after strand installation given the area would not be covered by any strand. Issue will be resolved at a later time.

Divider PL halves showing bare metal and paint chipping along the edge at some locations.

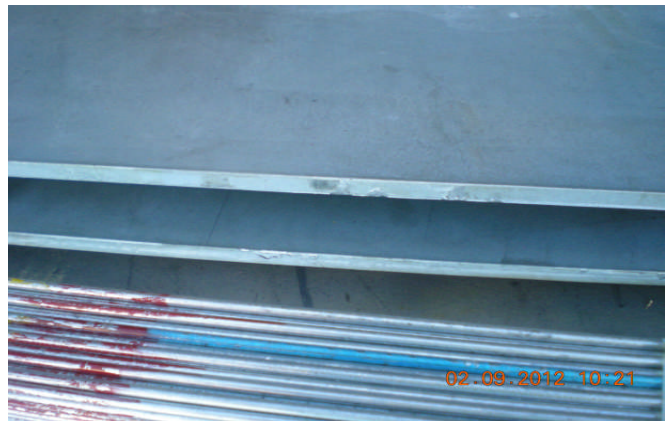
Divider PL halves showing bare metal and paint chipping along the edge at some locations.

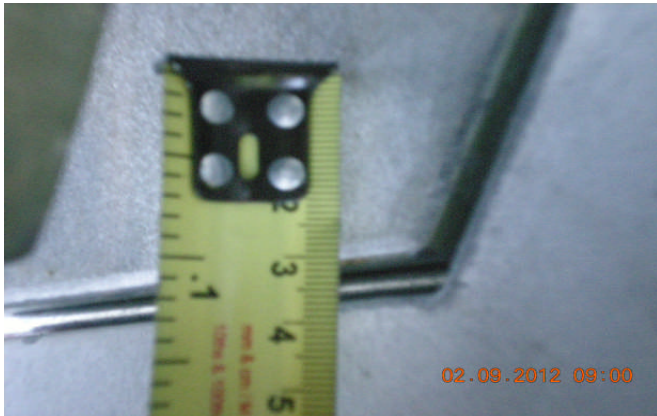
•Yesterday another CT engineer indicated that a gap @ the last half divider plate on the SDS (2nd divider plate from the bottom) had a gap @ the seam in the castellation. I took a measurement of 3.5mm to 4mm which is less than 5.4mm of the wire diameter. No issue. I verified another gap on the NDS and it measured about 5.5mm to 6mm. I informed ABF engineer and foreman and the foreman indicated that they will try to close the gap as much as possible on divider plate G-47. I informed CT leads. ABF attempted to close the gap as much as they could but they were not successful. Gap will stay at about 5.5 to 6mm. Issue closed.

DIVIDER PL G-47 - 5.5mm minimum gap between adjacent divider plate near the edge of the NDS

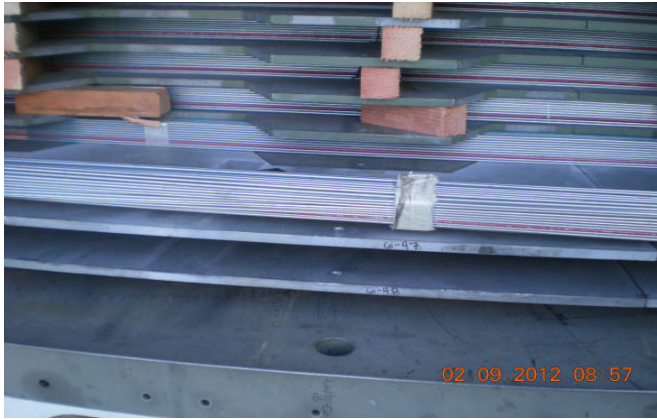
DIVIDER PL G-47 - 2nd divider plate from the bottom

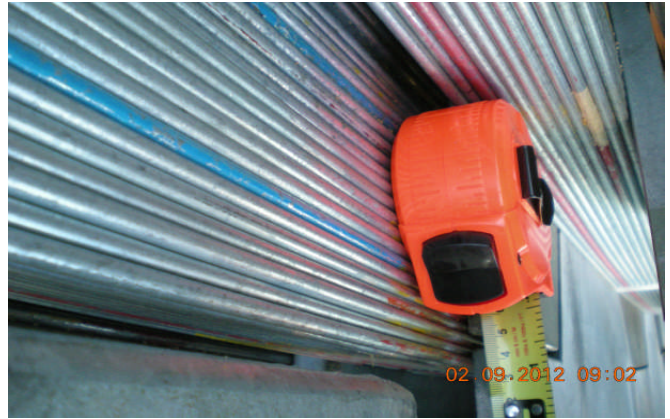
DIVIDER PL G-47 - 5.5mm minimum gap between adjacent divider plate near the edge of the NDS
